SCANNING PHOTOVOLTAGE TECHNIQUE FOR HIGH RESOLUTION  
NON-DESTRUCTIVE CHARACTERIZATION OF SEMICONDUCTOR WAFERS

L.J. Palkuti  
A.A. Milgram  
Advanced Research and Publication Corporation  
Sunnyvale, CA 94086

October 1985

Final Report for Period July 1984 - January 1985

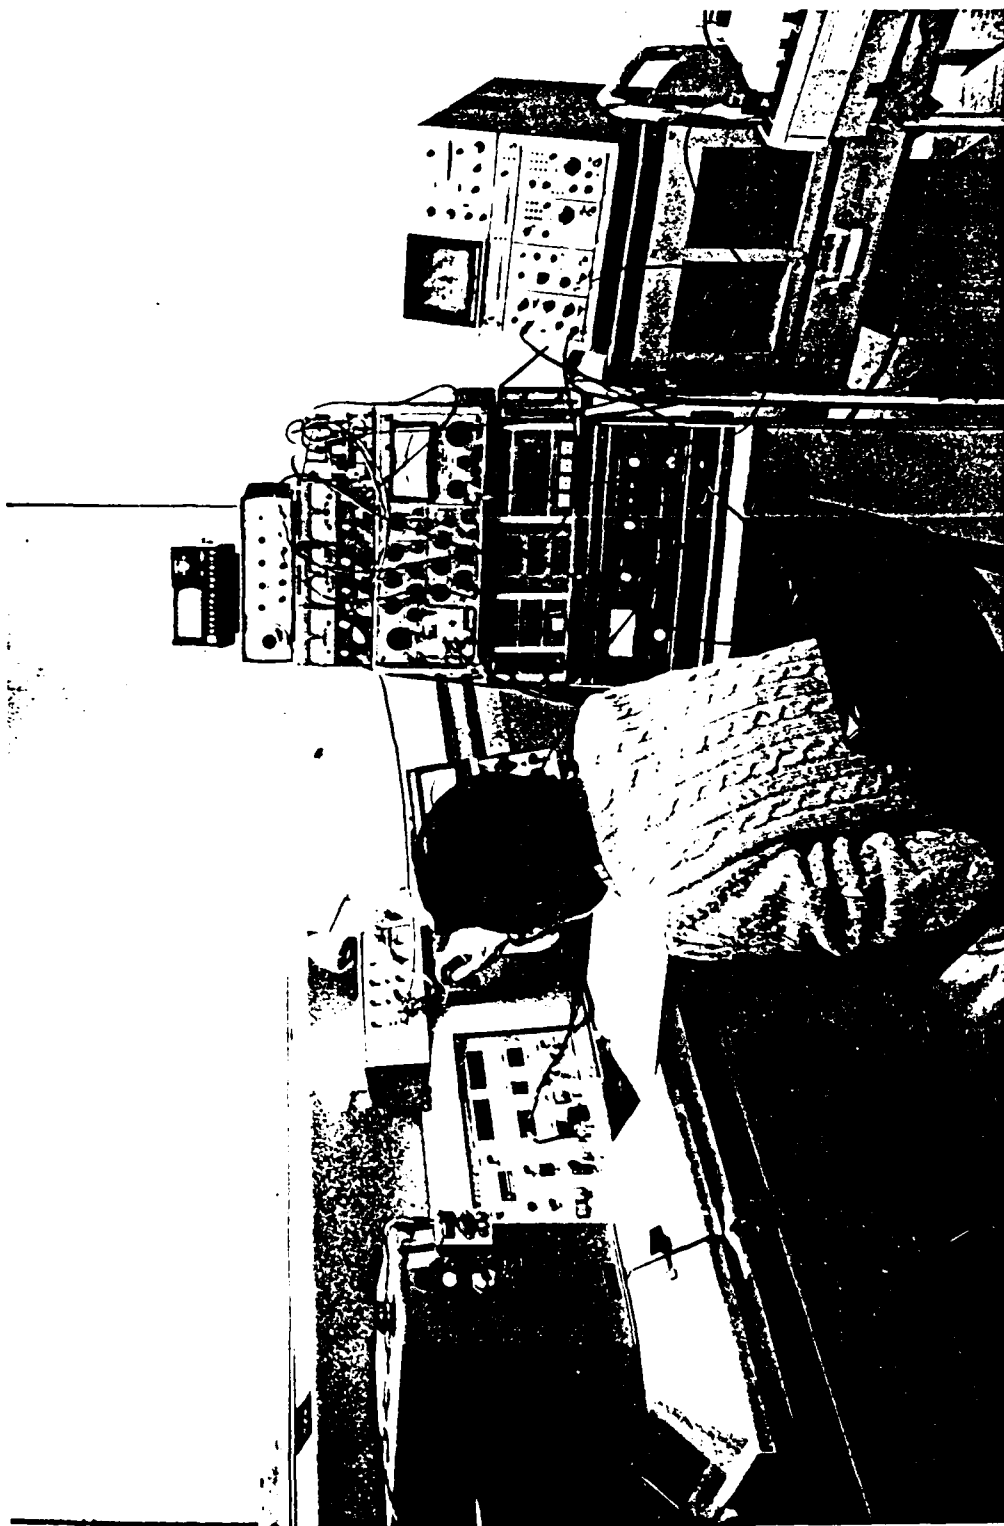
Figure 1. Photograph of Automated Scanning Photovoltage System.

The experimental configuration shown in Figure 1 was used to produce high-resolution (near one micron) scanning photovoltage (SPV) responses in GaAs
